REPORT / RECOMMENDATION

Subject: Traffic Safety Committee Report of January 2, 2014

TRAFFIC SAFETY COMMITTEE REPORT

Thursday, January 2, 2014

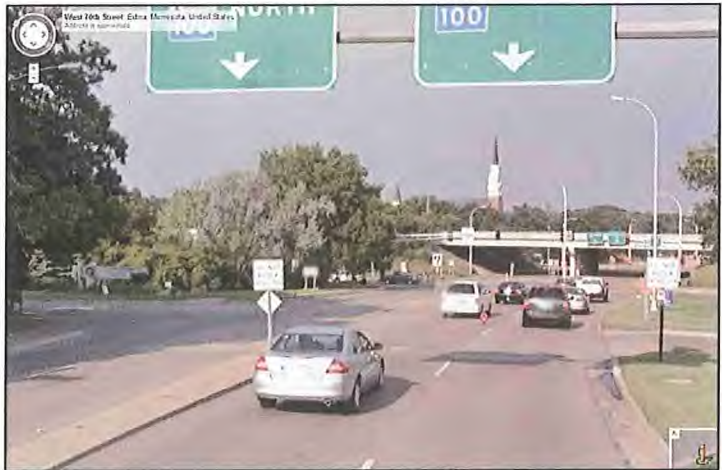
Currently there are two do not block intersection signs located on eastbound 70th Street, located at the intersection. 70th

Street is a divided 4 lane roadway. The south leg of the intersection is an entrance for a parking lot. The north leg of the intersection, Rabun Drive, is the only entrance on the south side of Brookview Heights neighborhood.

Picture: Rabun Dr. and 70th St. taken from Google maps

After discussion the staff recommends installation of orange plaques above and below the existing "do not block intersection" signs to help draw attention to the signs.

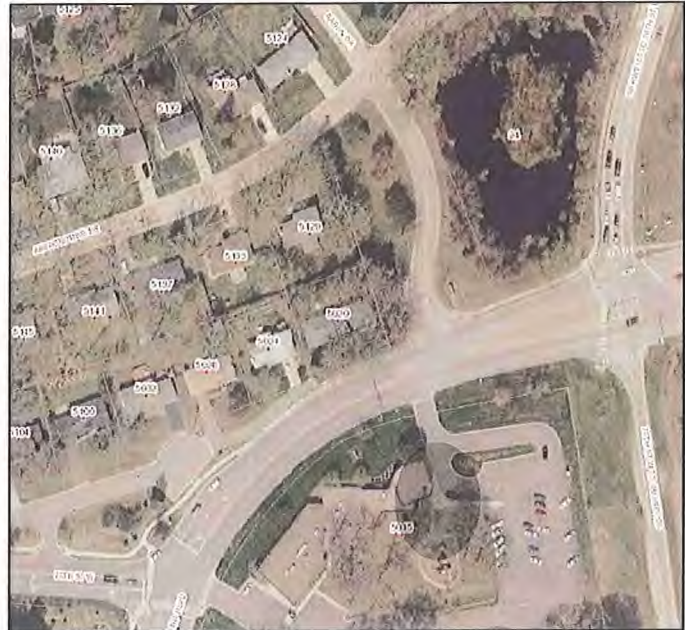
Map: Rabun Dr. and 70th St.

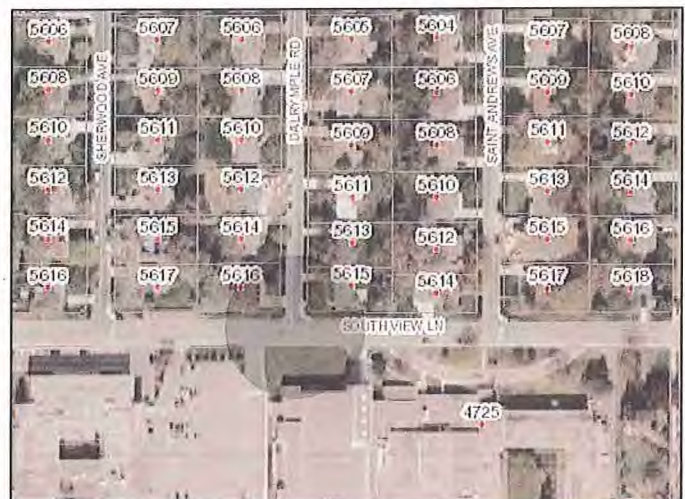
This location is near schools and a community center. Currently there's a painted crosswalk with pedestrian crossing signs, a sidewalk on the south side of the road and a pedestrian landing on the north side. There is a stop sign on southbound Dalrymple. There are no recorded crashes at the intersection of South View and Dalrymple.

Map: South View and Dalrymple

Counts of pedestrians were taken at the intersection. A maximum total of 19 pedestrians were recorded crossing South View Lane within a two-hour period. The ADT for this intersection is 3701 vehicles with the peak hour being 7:00 am. A gap study was performed during the peak hour, resulting in 8.8 gaps.

After discussion the staff recommends denying the request for additional signage, since existing signage and markings are already adequate based on the city policy.

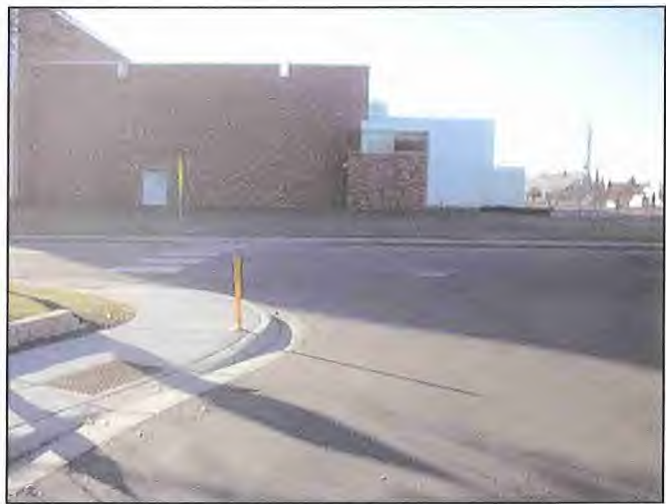
Photo: South View Ln and Dalrymple Rd from the north

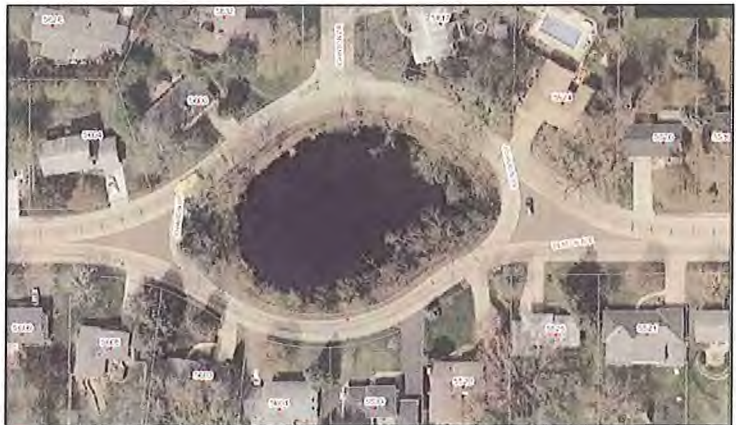
Currently Benton Avenue has a one-way traffic circle with three exits. There are parking bays on the west and east sides of the traffic circle as shown on the map.

Map: Benton Ave. parking bay

A traffic study was performed, with a camera set up to the west of the parking bay. In a 24 hour period; 2839 vehicles passed the parking bay, 5 vehicles parked in this area, 1 vehicle performed a U-Turn.

After discussion the staff recommends denying the request for a No U-Turn sign.

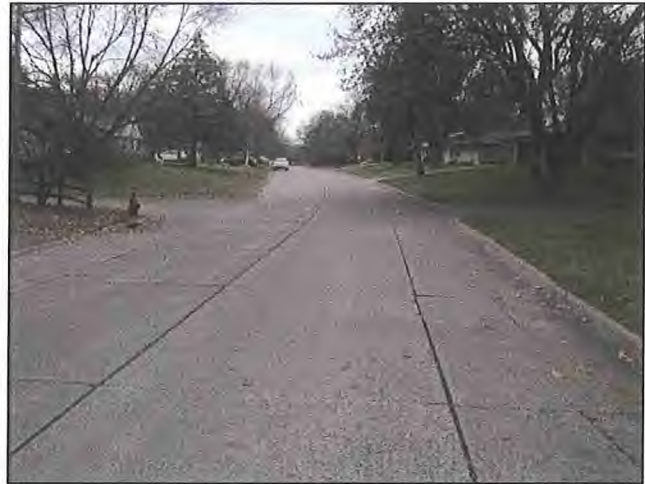
During the December 4, 2013 meeting, the traffic safety committee recommended looking further into the crash from 2013 to determine if it was an unavoidable crash. In an overview of the crash, the driver of the vehicle struck crossing St. Johns slowed down, but did not see the vehicle traveling down St. Johns. It was noted the Yield sign has a tree near it with a branch hanging down which may or may not be blocking the Yield sign.

Photo: St. Johns Ave. looking south

After discussion the staff recommends denying the request for replacing the Yield signs with Stop signs. Staff will check to make sure the Yield signs are clear of obstruction.

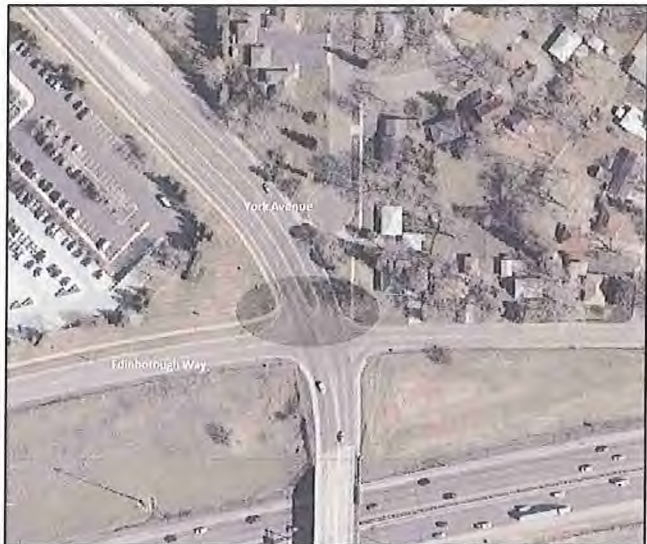
Currently there exist crosswalks on the north and west legs of the intersection, but without any signage. There is a median, crossing island, crossing York Avenue which can be used as a safe haven for pedestrians. There are stop signs on Edinborough Way. The speed limit on York Avenue is 35 mph.

Map: York Ave. and Edinborough Way

After discussion the staff recommends further study and communicating with Hennepin County before making a recommendation.

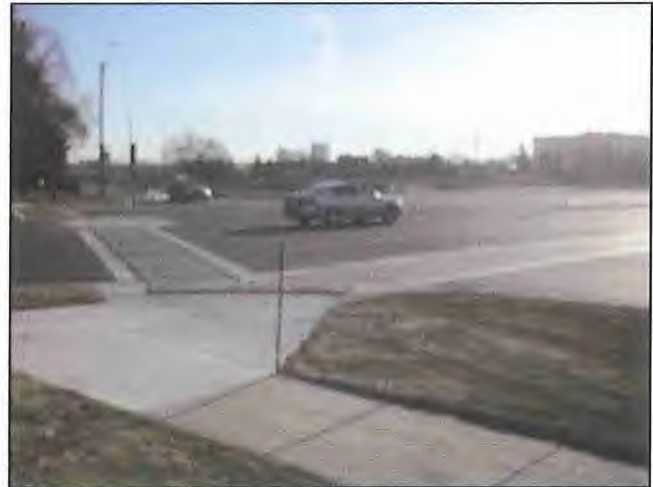
The ADT for this intersection was found to be 11,662, with the peak hour occurring at 4:45 pm. A gap study was performed during this peak hour. The MNDOT Traffic Signal Timing and Coordination Manual states on divided roadways; *a divided road is one with a median island over 6 feet wide and includes a pedestrian pushbutton in the median. If a pushbutton is not in the median, the recommended practice, pedestrian clearance interval must cross them completely from near side curb to far side curb.* This means for the gap study the crossing island should not be considered a “safe haven”. The gap study

Picture: York Ave and Edinborough Way from NW

resulted in 0.8 gaps on average for a 5 minute period. If the crossing island were to be considered a “safe haven”, the gaps for northbound traffic were 10.5 and for southbound traffic were 14.3 gaps on average for a 5 minute period. The Local Traffic Control list recommends installation of an overhead mounted flasher for less than 3 gaps, and pavement markings and signage for above 5 gaps.

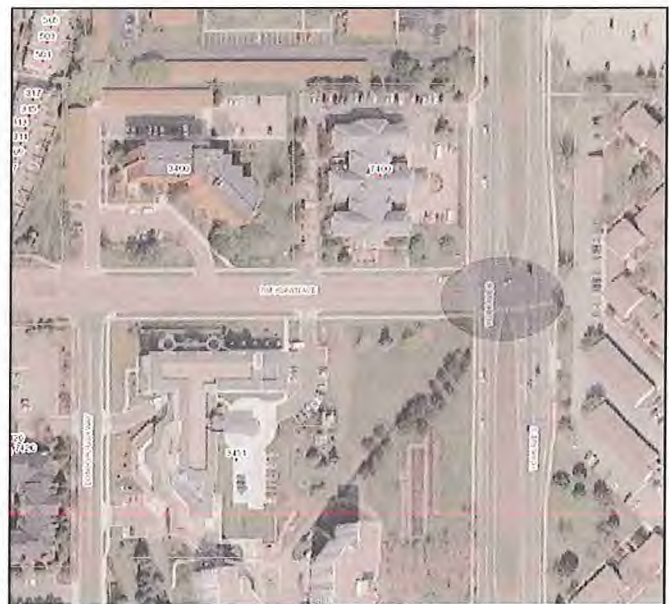
Currently there are painted crosswalks on the south and west legs of the intersection. There are crosswalk warning signs located on York Avenue north, south, and immediately at the crosswalk. No signage is located on Parklawn Avenue. York Avenue is 6 lanes wide, including 2 turn lanes at the crosswalk, with a distance of 126 feet from curb to curb. Parklawn is 4 lanes wide, with a distance of 65 feet from curb to curb. There have been 9 accidents at this intersection since 2009.

Map: York Ave. and Parklawn Ave.

After discussion the staff recommends further study and communicating with Hennepin County before making a recommendation.

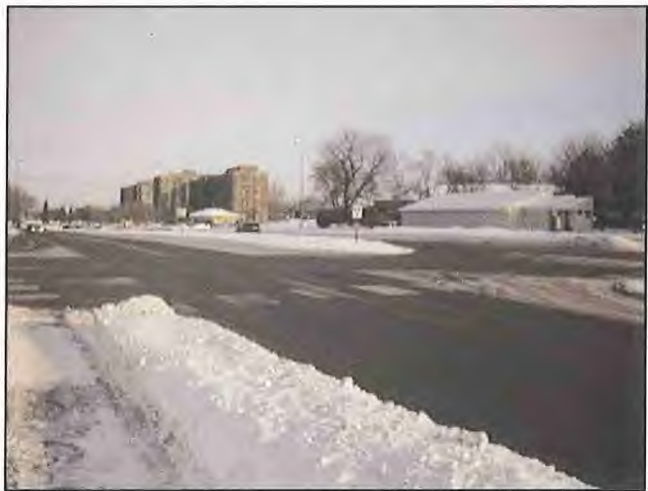
A traffic gap count was taken during the peak hour, 5 pm. The average gaps per 5 minute period on York Avenue were 0. The average gaps per 5 minute period going across Parklawn Avenue were 1.7. Both of these were below 3 gaps, according to the Local Traffic Control list it's recommended to install an overhead mounted flasher.

Picture: York Ave. and Parklawn Ave. from the south

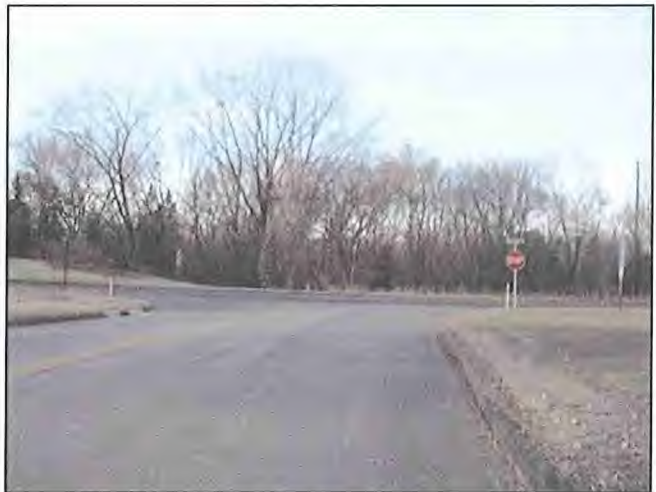
Currently there exist a stop sign on Valley Lane westbound. There is a left turn lane for southbound Valley View Road. There are 8 recorded crashes at this intersection since 2008, including several failures to yield the right-of-way and a vehicle making a left turn.

Picture: Valley View Rd. and Valley Ln. facing west

After discussion the staff recommends including study of this intersection along with traffic analysis of Tracy / TH 62 associated with future Tracy Avenue reconstruction before making a recommendation.

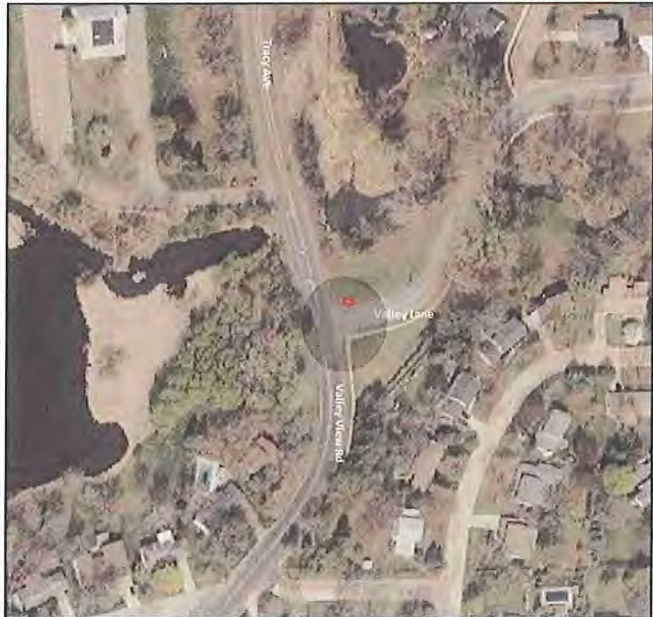
The volume of traffic entering the intersection from Valley View Road (major street) did not average at least 200 vehicles per hour over the same 8 hour period. There were a total of 980 southbound left turns, 712 northbound right turns, 842 westbound right turns and 374 westbound left turns during the 24 hour study.

Map: Valley View Rd. and Valley Ln.

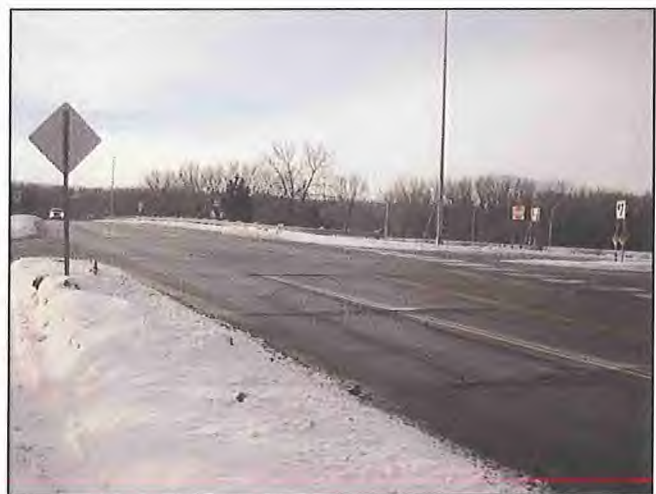
Currently there are stop signs located on westbound Valley View Road and the exit ramp from highway 62. The exit ramp has a right turn only lane and a left turn or through lane. Tracy Avenue has a left turn only lane northbound. The closest stop signs on Tracy Avenue are located at Olinger Boulevard to the north, and no close stop signs are located to the south.

Picture: Tracy Ave. and Valley View Rd. from north

After discussion the staff recommends including study of this intersection along with traffic analysis of Tracy / TH 62 associated with future Tracy Avenue reconstruction before making a recommendation.

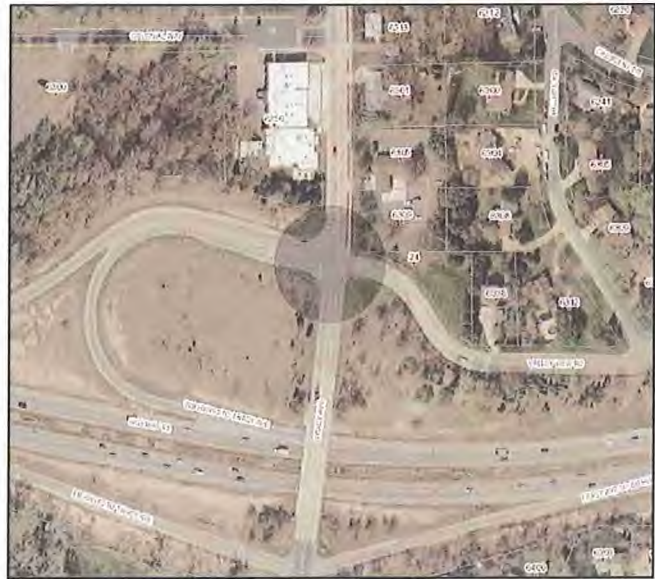
There most reported crashes in a 12-month period were four from 4/06 through 4/07, all of which were right angle collisions due to a failure to yield the right-of-way. As shown in the above table, during an 8 hour period greater than 300 vehicles per hour entered the major street approaches and greater than 200 vehicles per hour entered the minor street approaches. The average delay for vehicles crossing Tracy Avenue was calculated during the peak hour for the minor approaches, 17:30 to 18:30. The average delay was calculated to be 54 seconds. It should be noted this delay may have been greater, only vehicles which could be seen were counted, some vehicles may have been out of view of the camera. This delay is still greater than the minimum requirement of 30 seconds.

Map: Tracy Ave. and Valley View Rd.

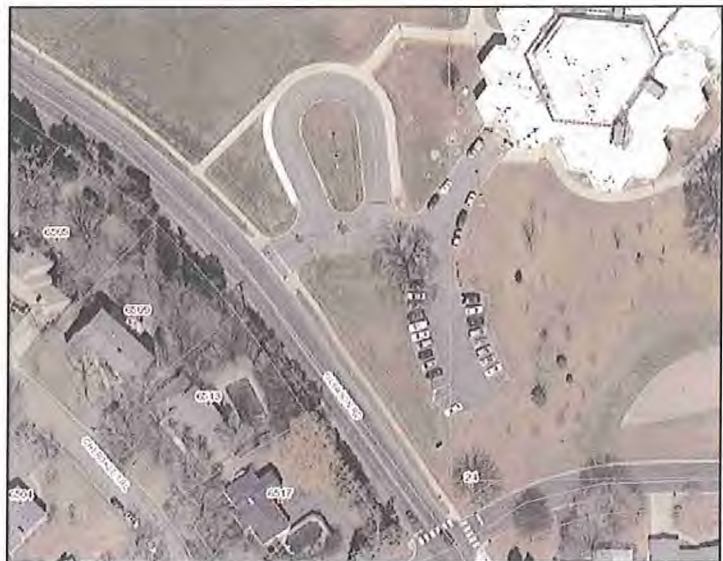
Currently there is a school speed limit of 20 mph on Gleason Road. There is No Parking on the east side of the road. There is No Parking on the east side of the road. There is an area for student drop off / pick up located on the school property as seen on the map. Gleason Road is 34 feet wide in this area.

Map: Gleason Rd. at Creek Valley School

After discussion the staff recommends coordination with the Parks Department and the School District for further study.

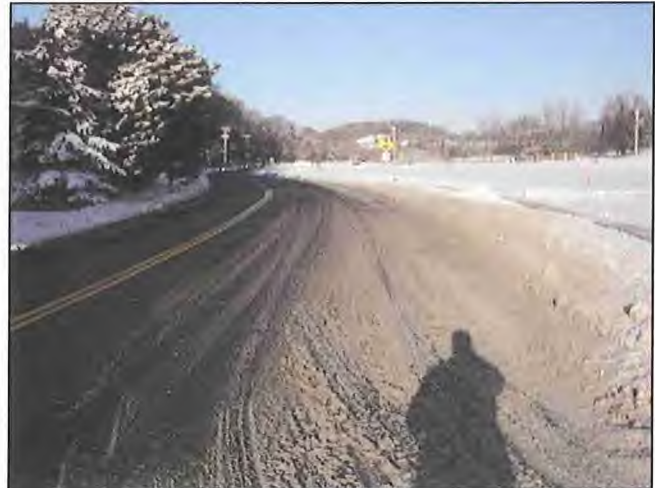
This request comes from a resident living in the area, they drive Gleason Road frequently. The requestor states; vehicles picking up children after school, at approximately 4 pm, are parking on and blocking Gleason Road, making it unsafe for travel. The requestor would like to see No Parking or No Pick Up on Gleason Road in front of the school.

Picture: Gleason Rd. from the south
